PBY Catalina

Walk Around

By William Scarborough

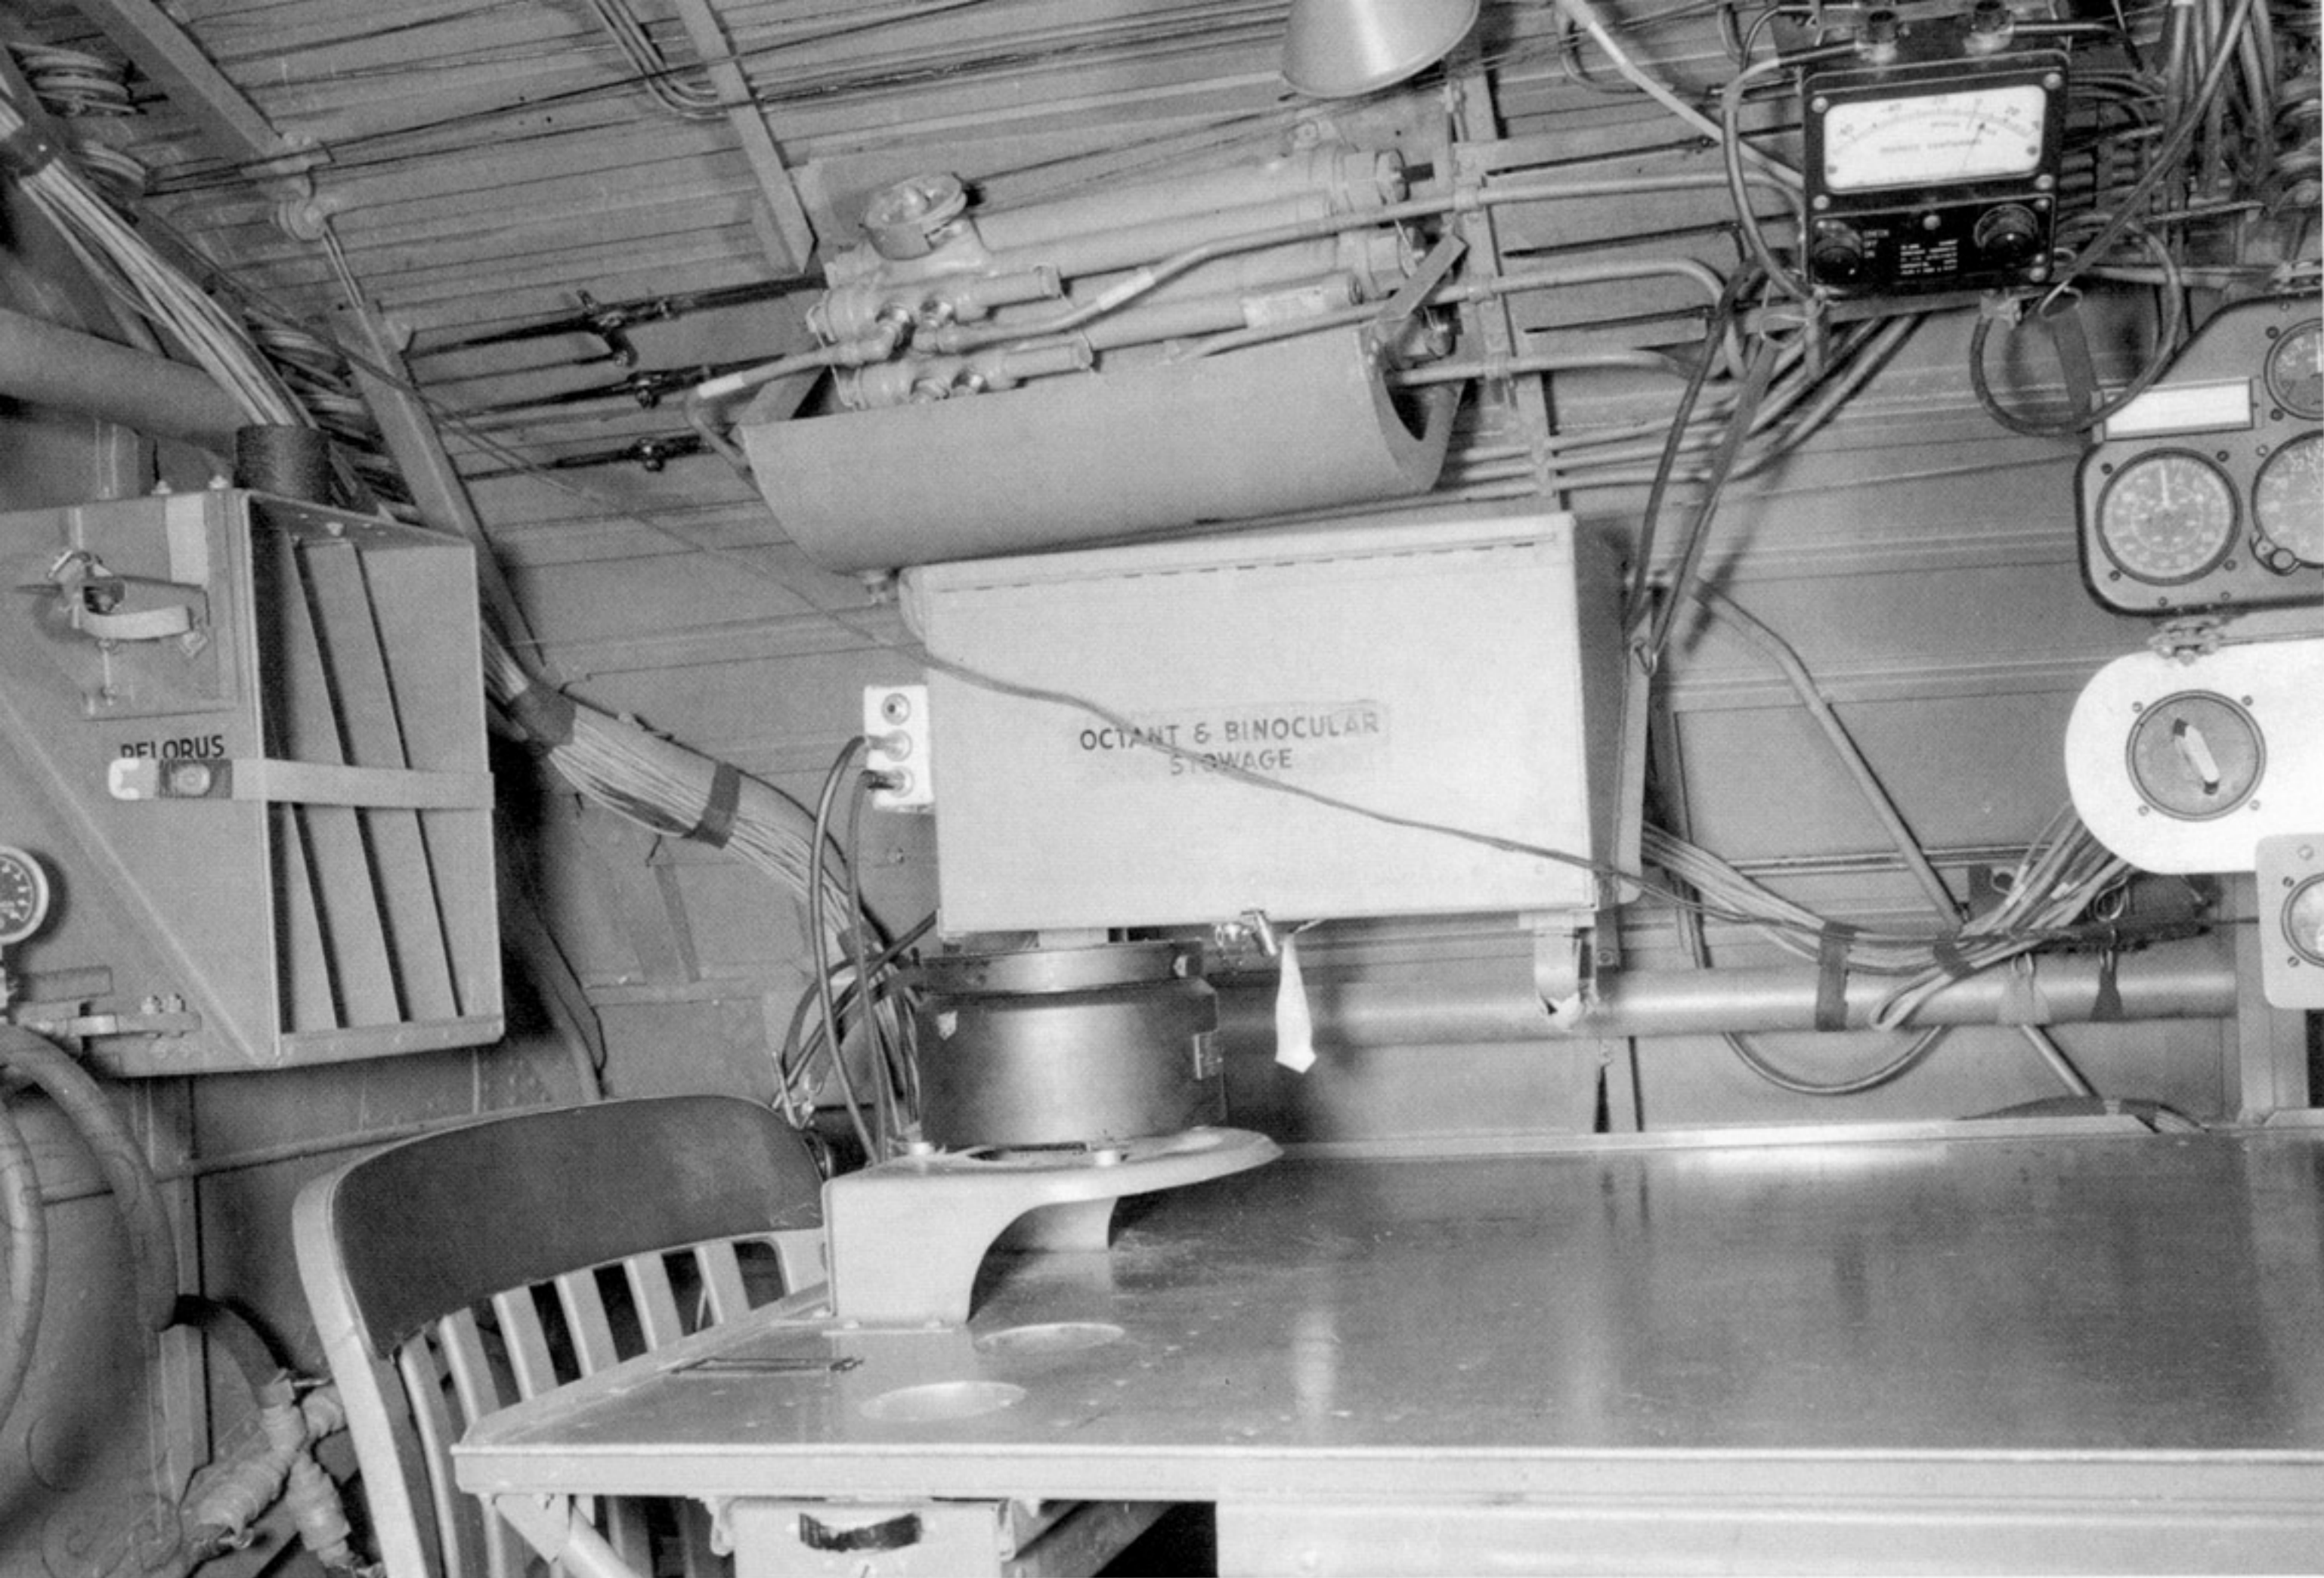
The opposite side of Navigator/Radio compartment. From left, forward: box for Navigation books with mount for Pelorus on side, Navigator's chair, Navigation table with drawer for chronometers (two were visible through the round windows in table), stowage for Octant and Binoculars. Compass was located on table at aft end. The meter at top and additional instruments above table are test equipment, standard Navigation instruments are above test equipment and include Temperature Gage (top) Airspeed, and Altimeter. The large drawer is for chart stowage. The semi-circular tray above Octant Stowage is a drip pan under hydraulic actuators for the auto pilot. The cone at top is the Navigator's Flood Light. (USN)

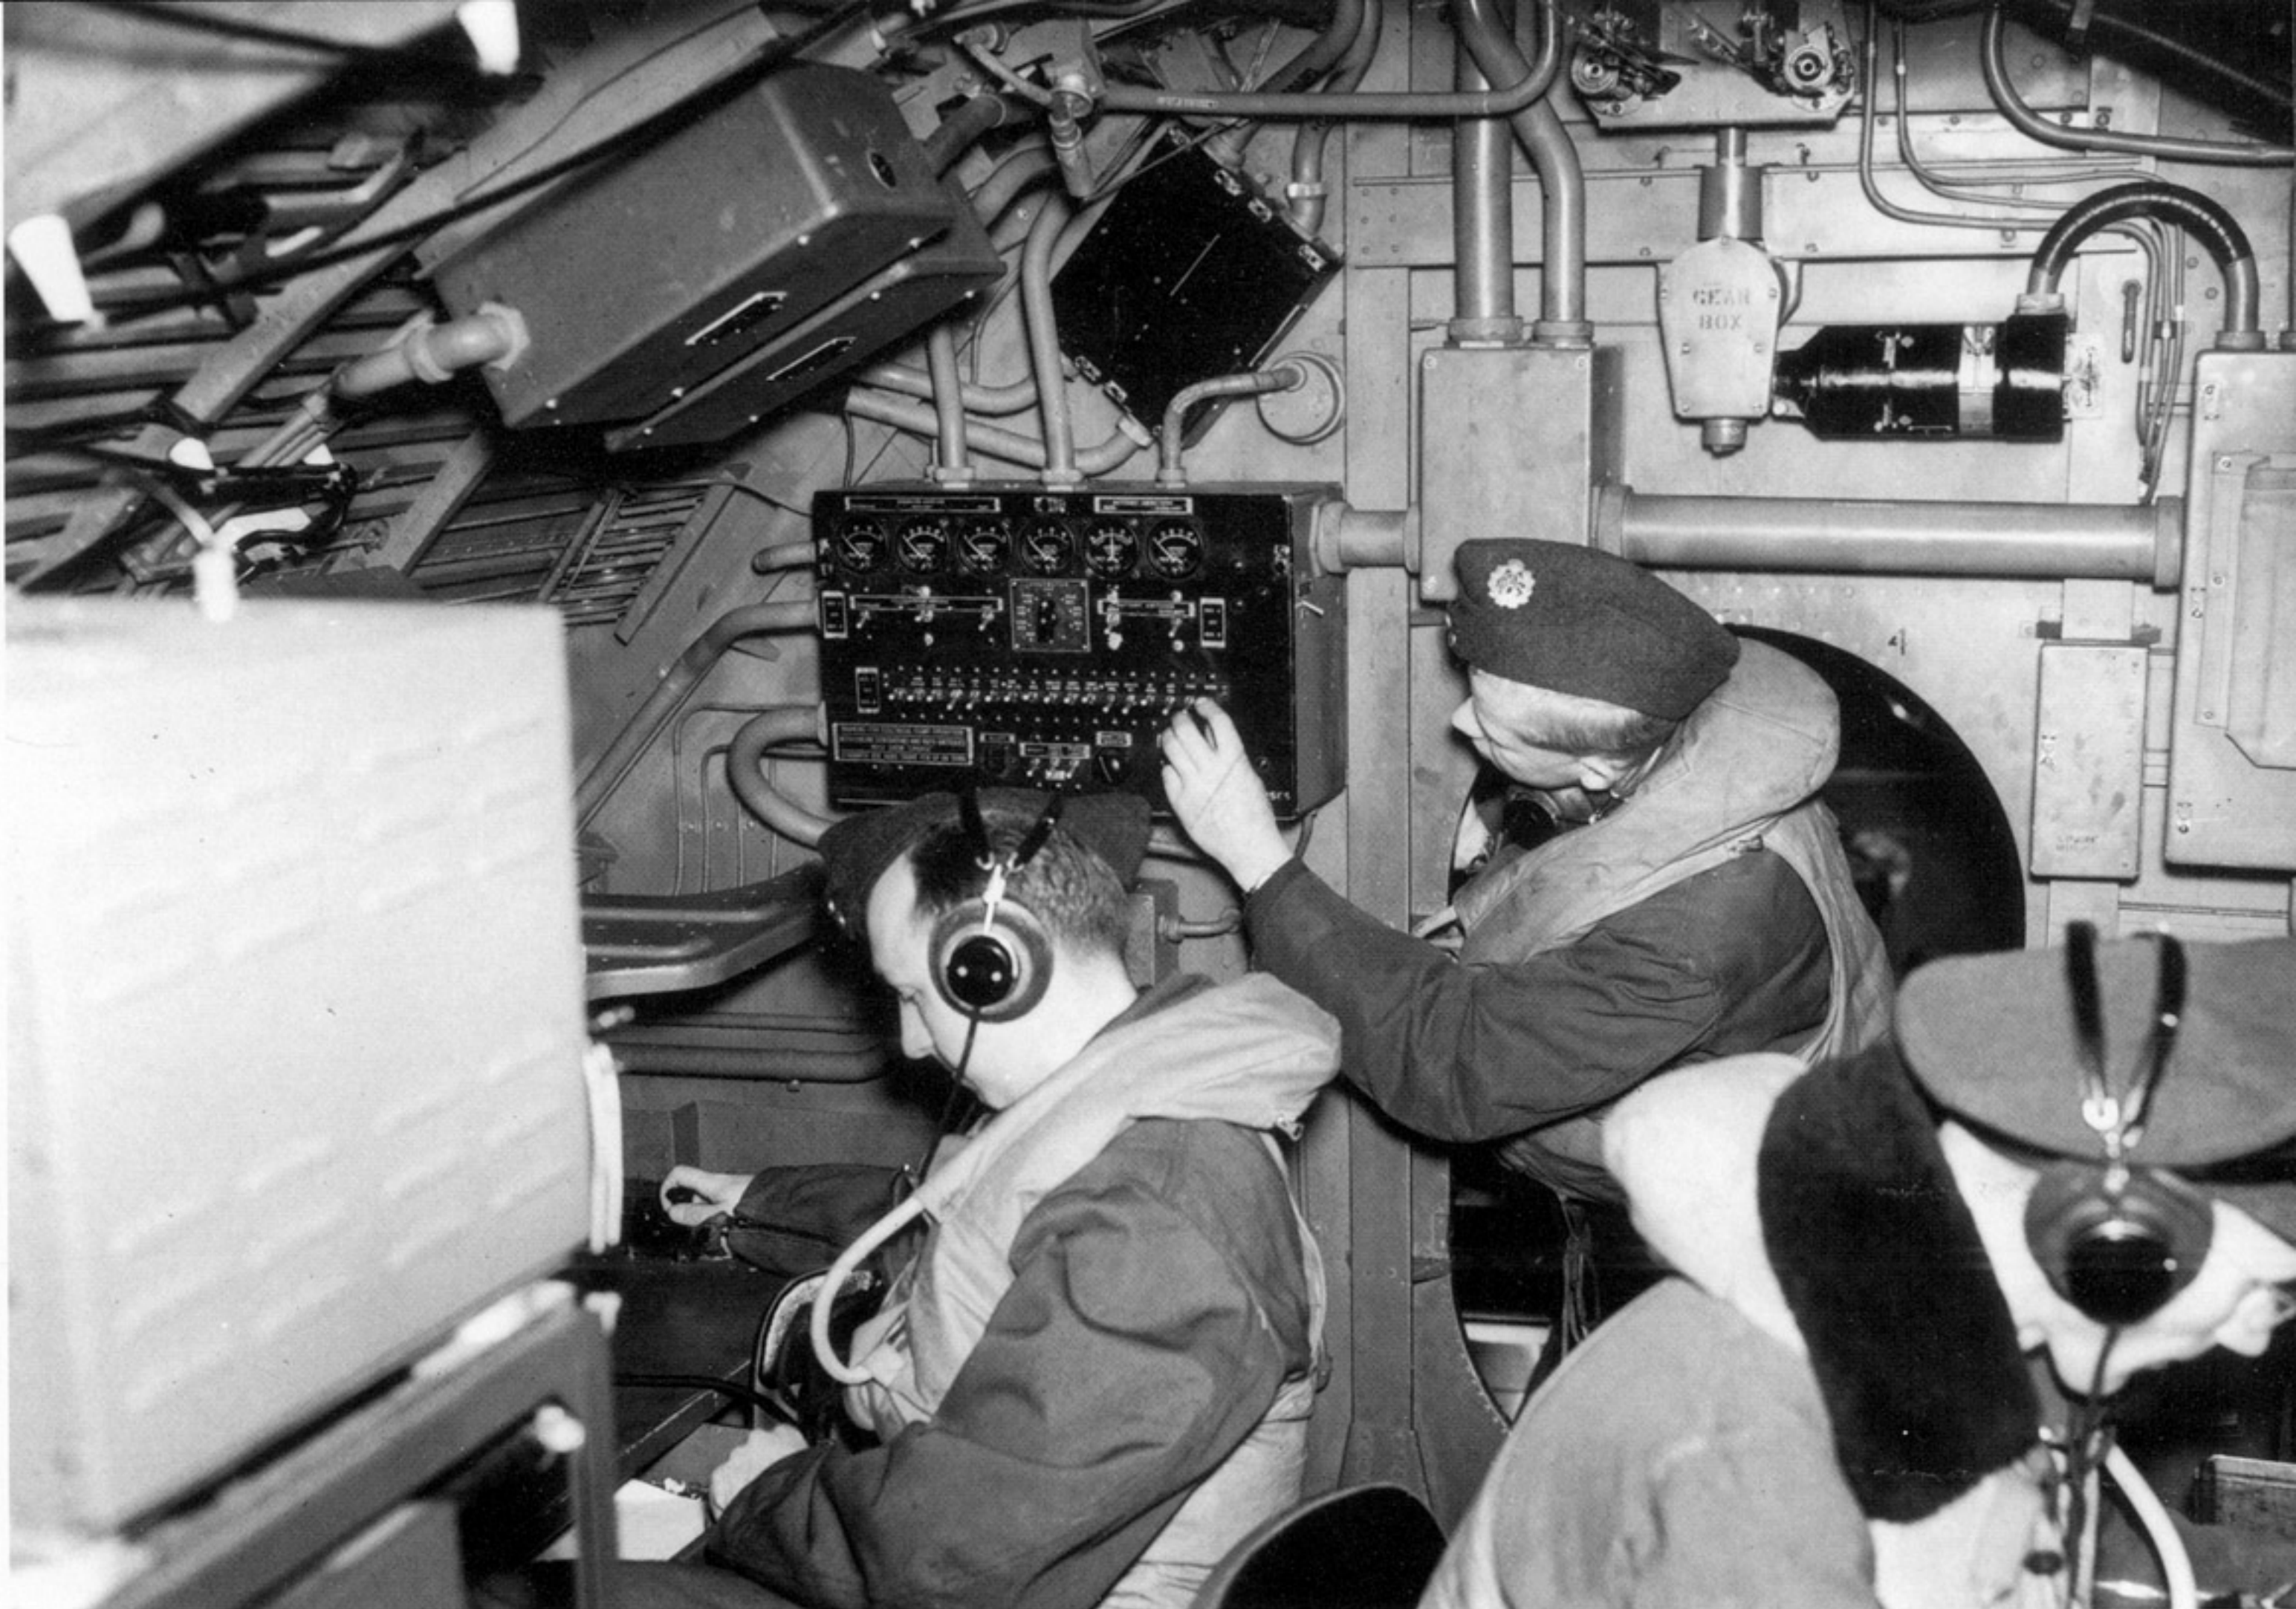
The navigation/radio compartment crew at work aboard "Wandering Wench" a Royal Canadian Air Force Canso, on 4 September 1943. The radio operator was at the left, the Navigator at right. The other crewman is adjusting the main electric power distribution panel. (Public Archives of Canada)

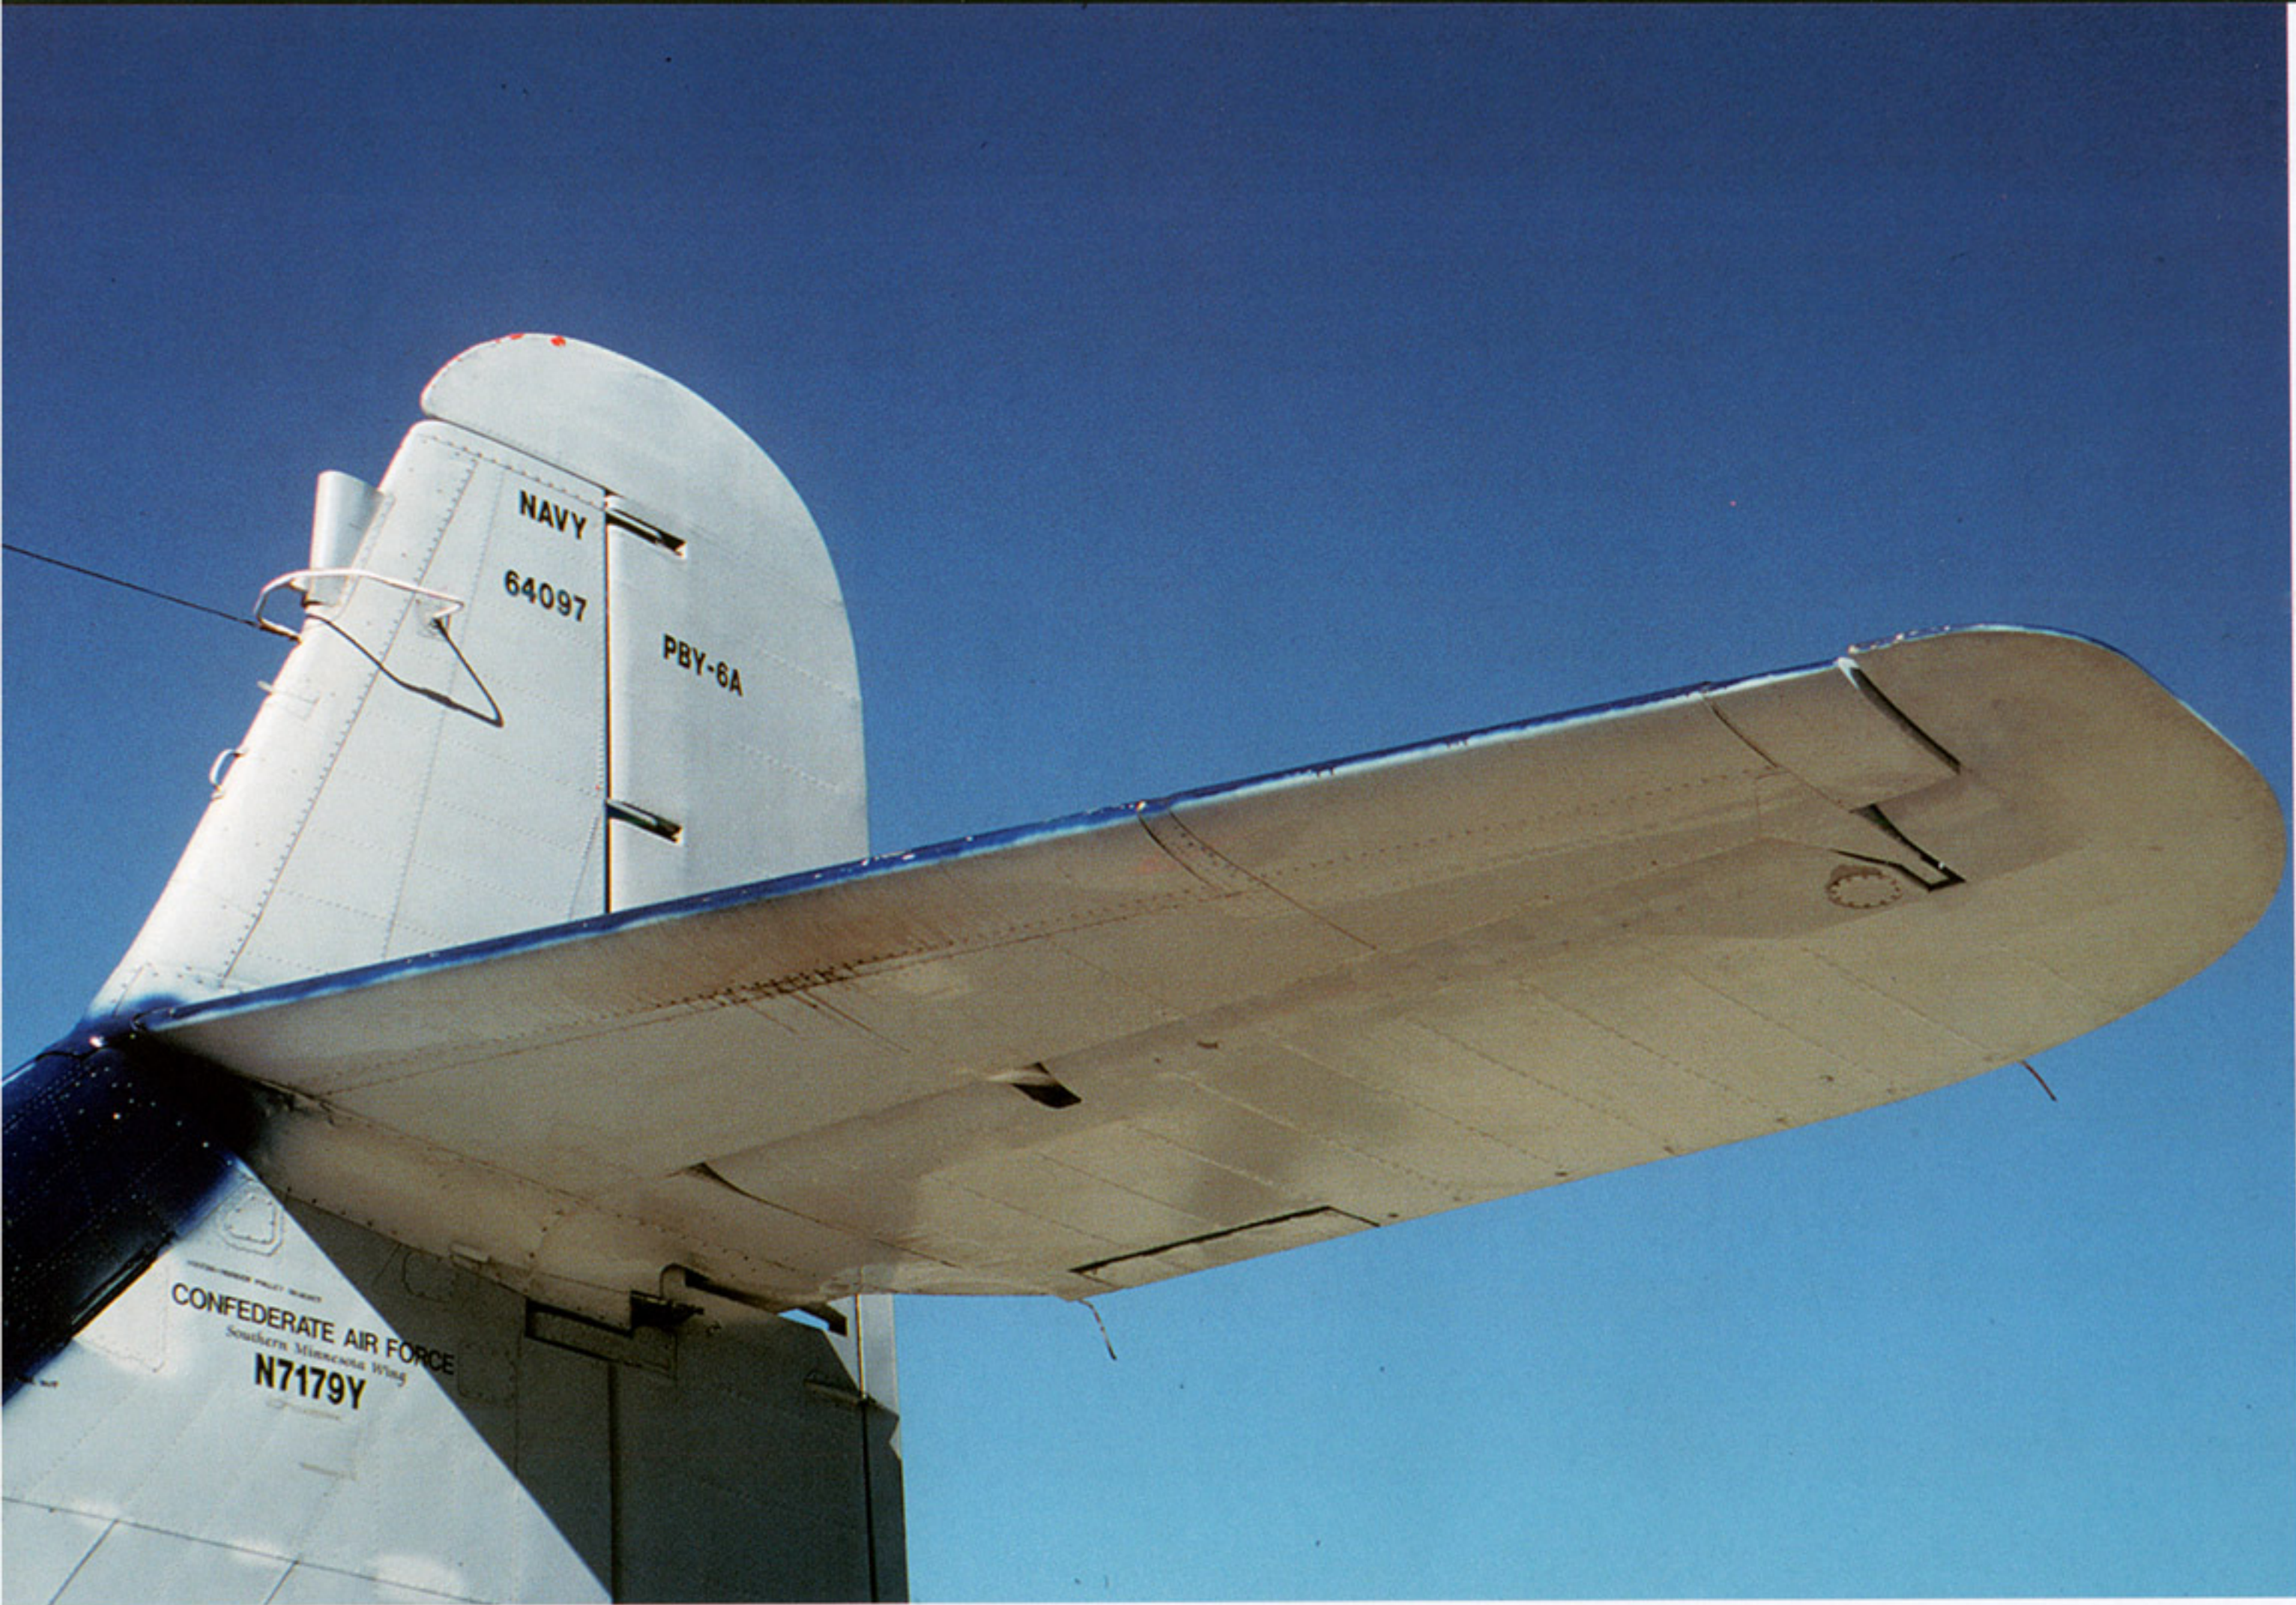
The vertical fin, rudder and port horizontal stabilizer of the restored PBY-6A that is operated by the Southern Minnesota Wing of the Confederate Air Force. The PBY-6A had a taller fin and rudder than the earlier PBY-5A, and this particular aircraft has been further modified with modern electronics antennas on the leading edge of the fin. The wicks hanging down from the elevator are static dischargers, which bleed off static electricity from the aircraft. (Mark Aldrich)

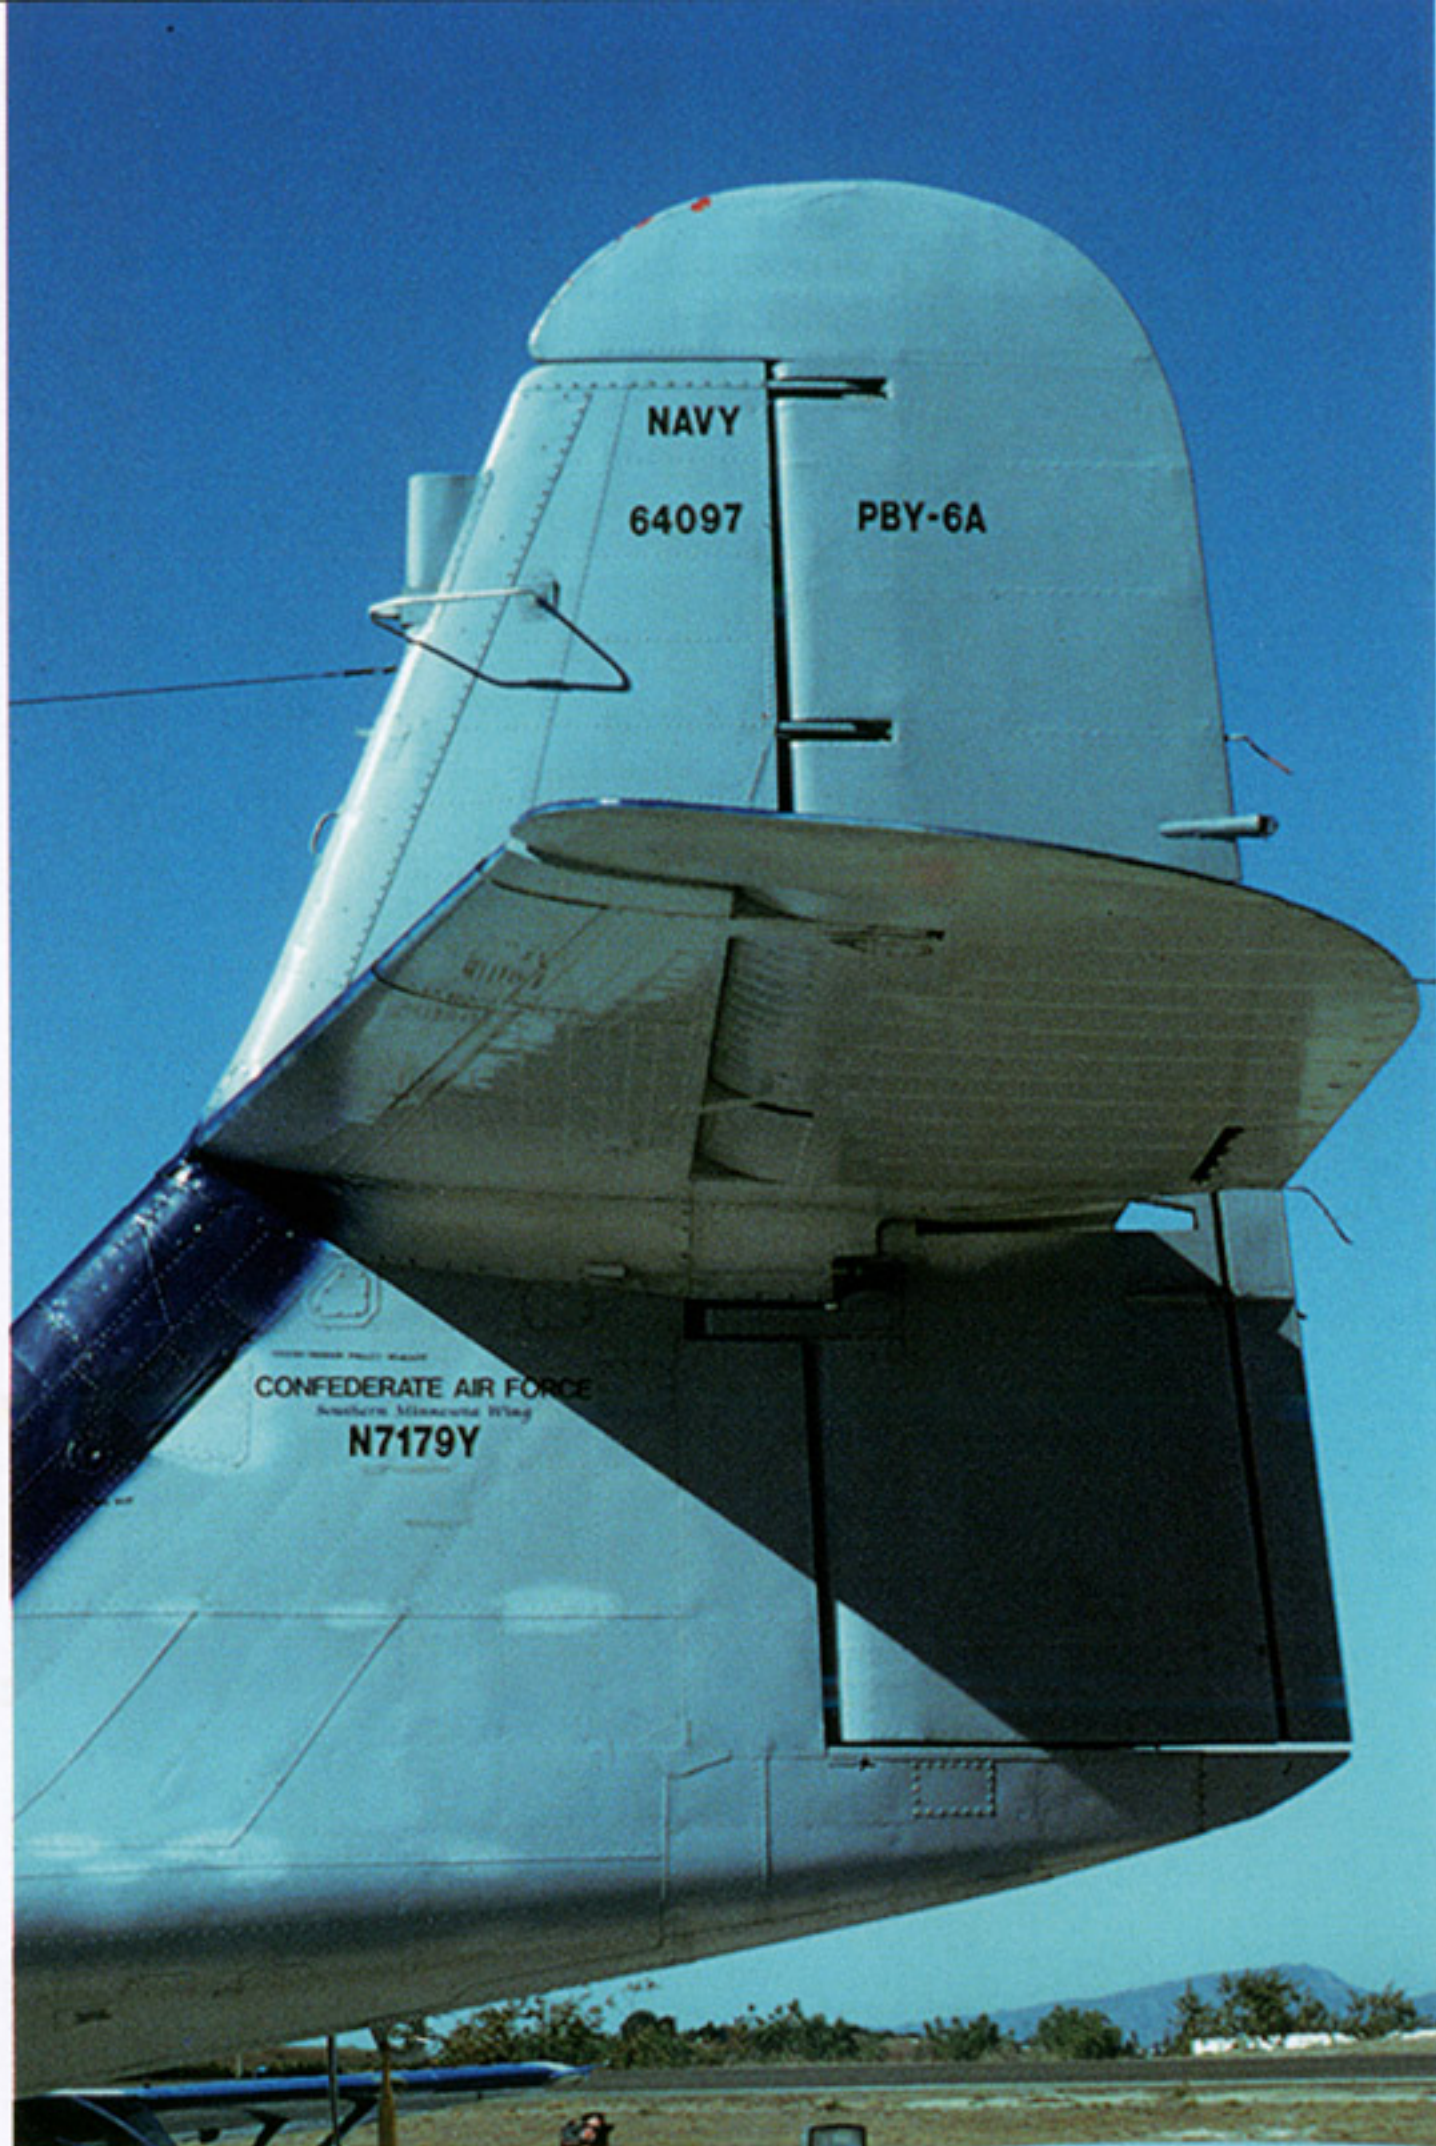
The taller fin and rudder was introduced on the Naval Aircraft Factory PBN-1 and the Navy specified it for production PBY-6As. Other than the modified tail, the aircraft was basically a PBY-5A. (Mark Aldrich)

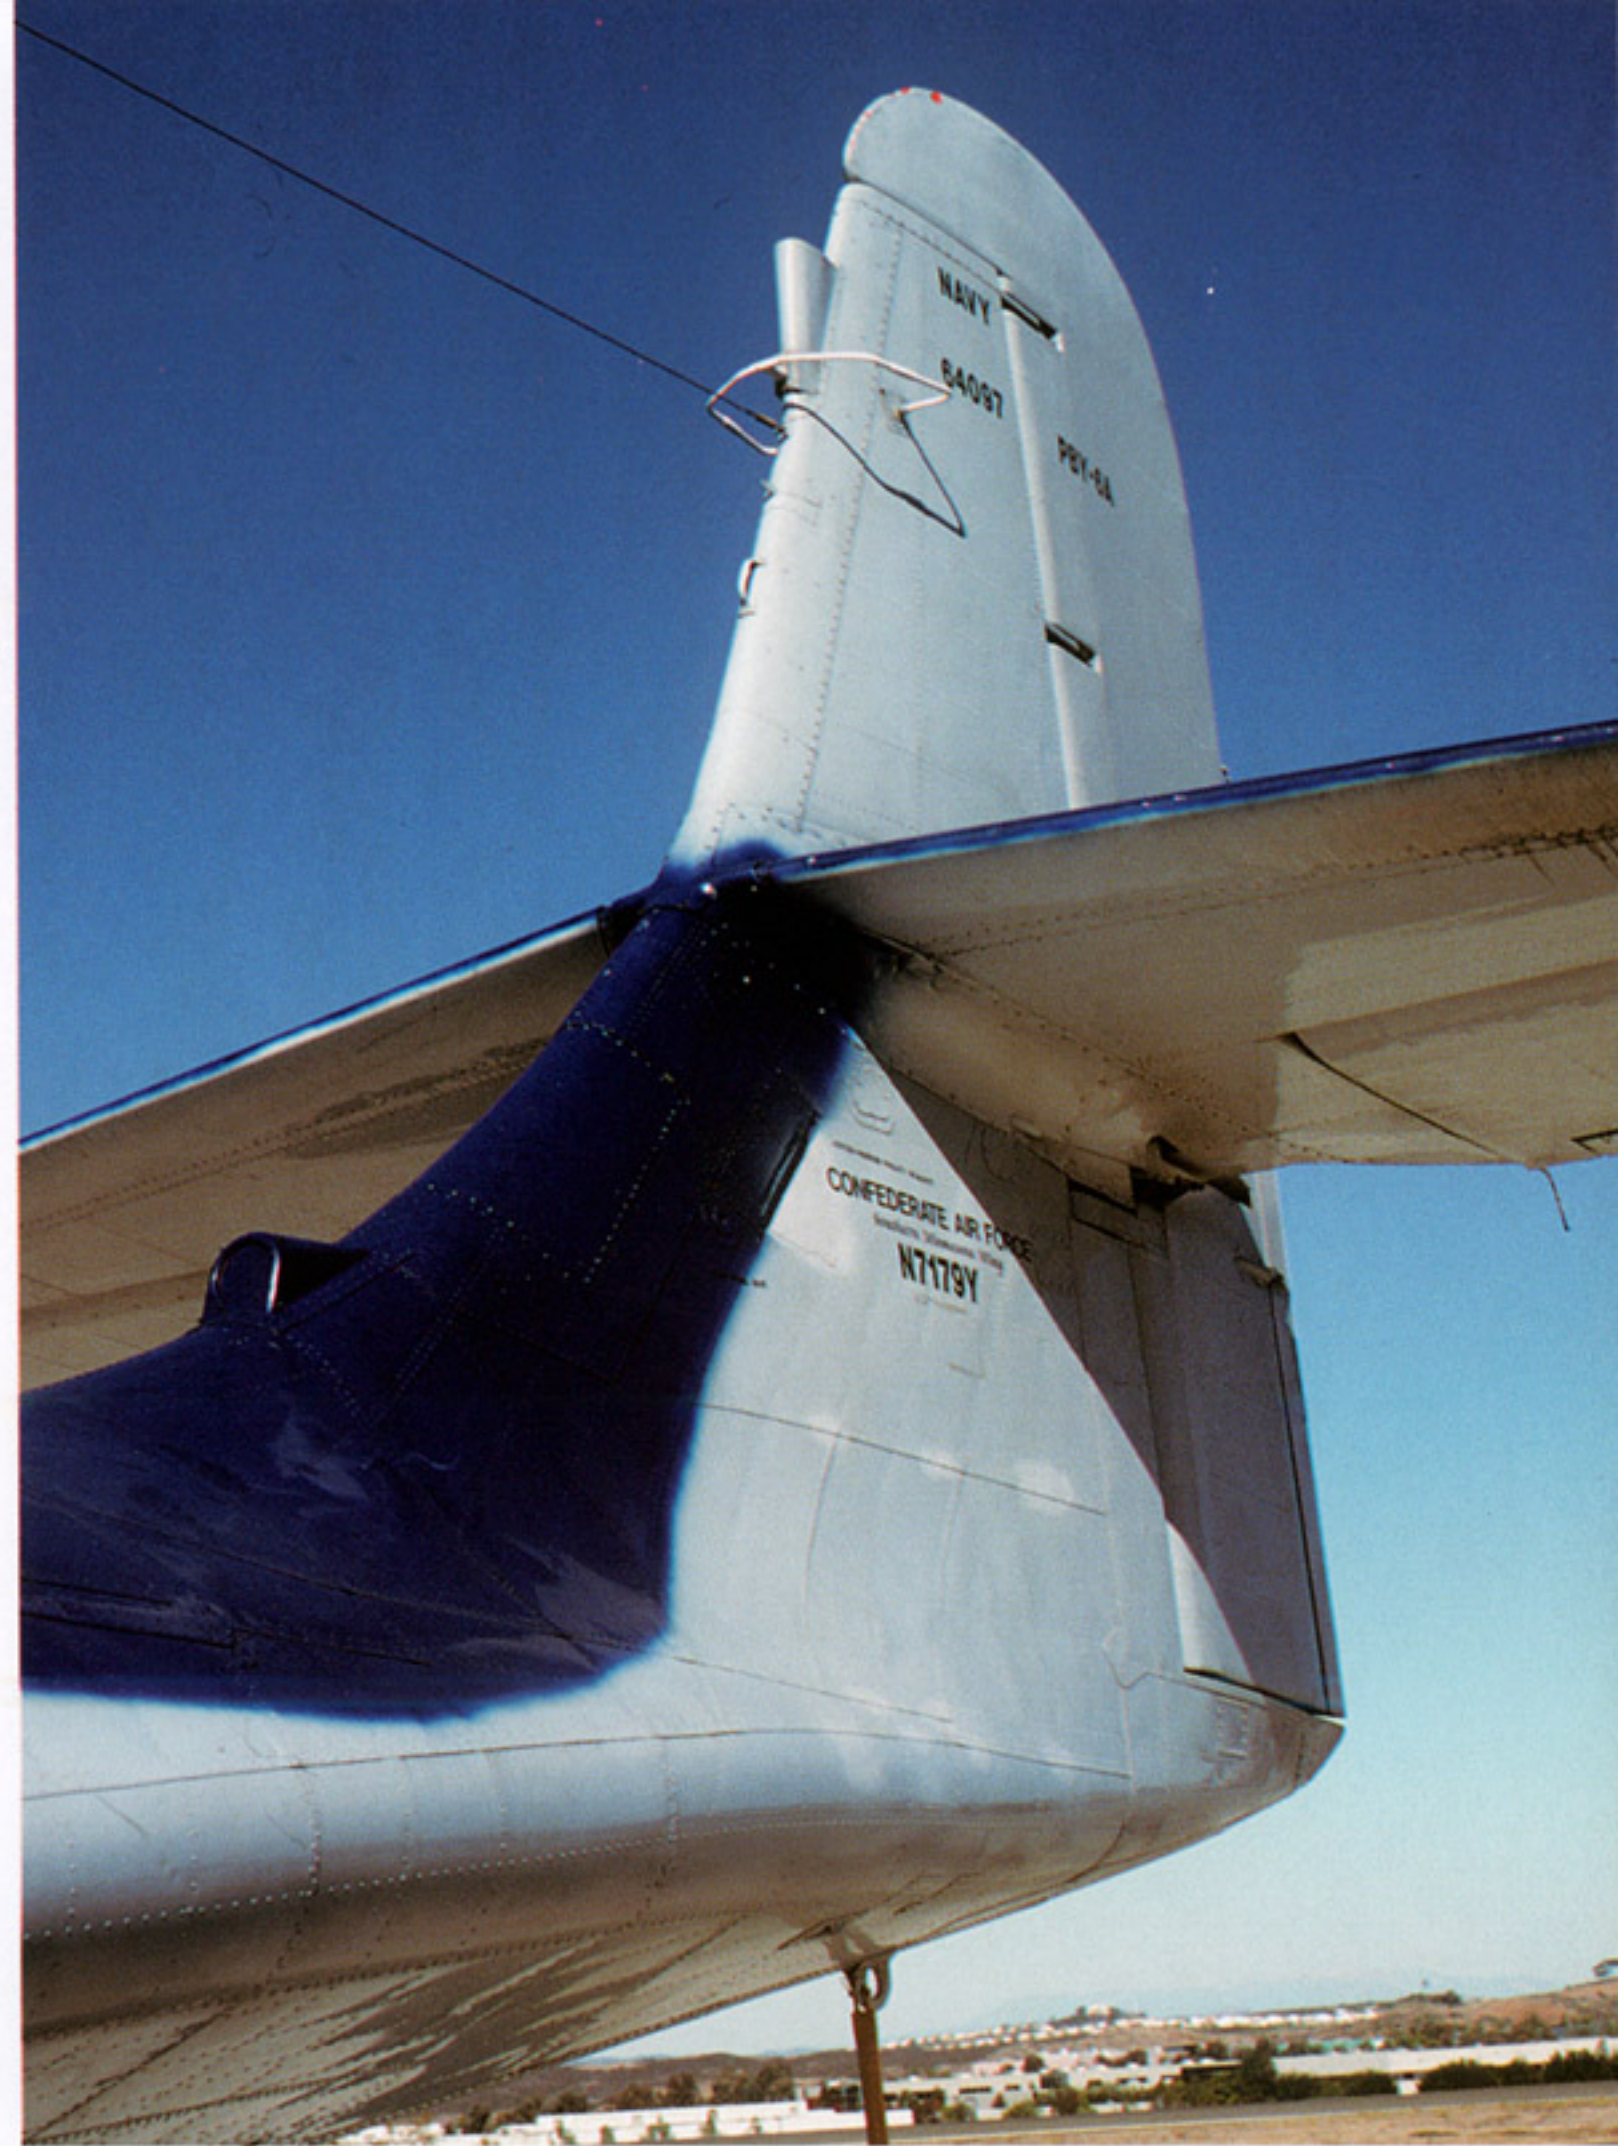
A tie-down rope is attached to the rear fuselage tie-down eye under the fin and rudder of this PBY-6A. Tie-down eyes were located under the nose, tail, leading edge of the outer wing panels and on each of the wing tip floats. (Mark Aldrich)

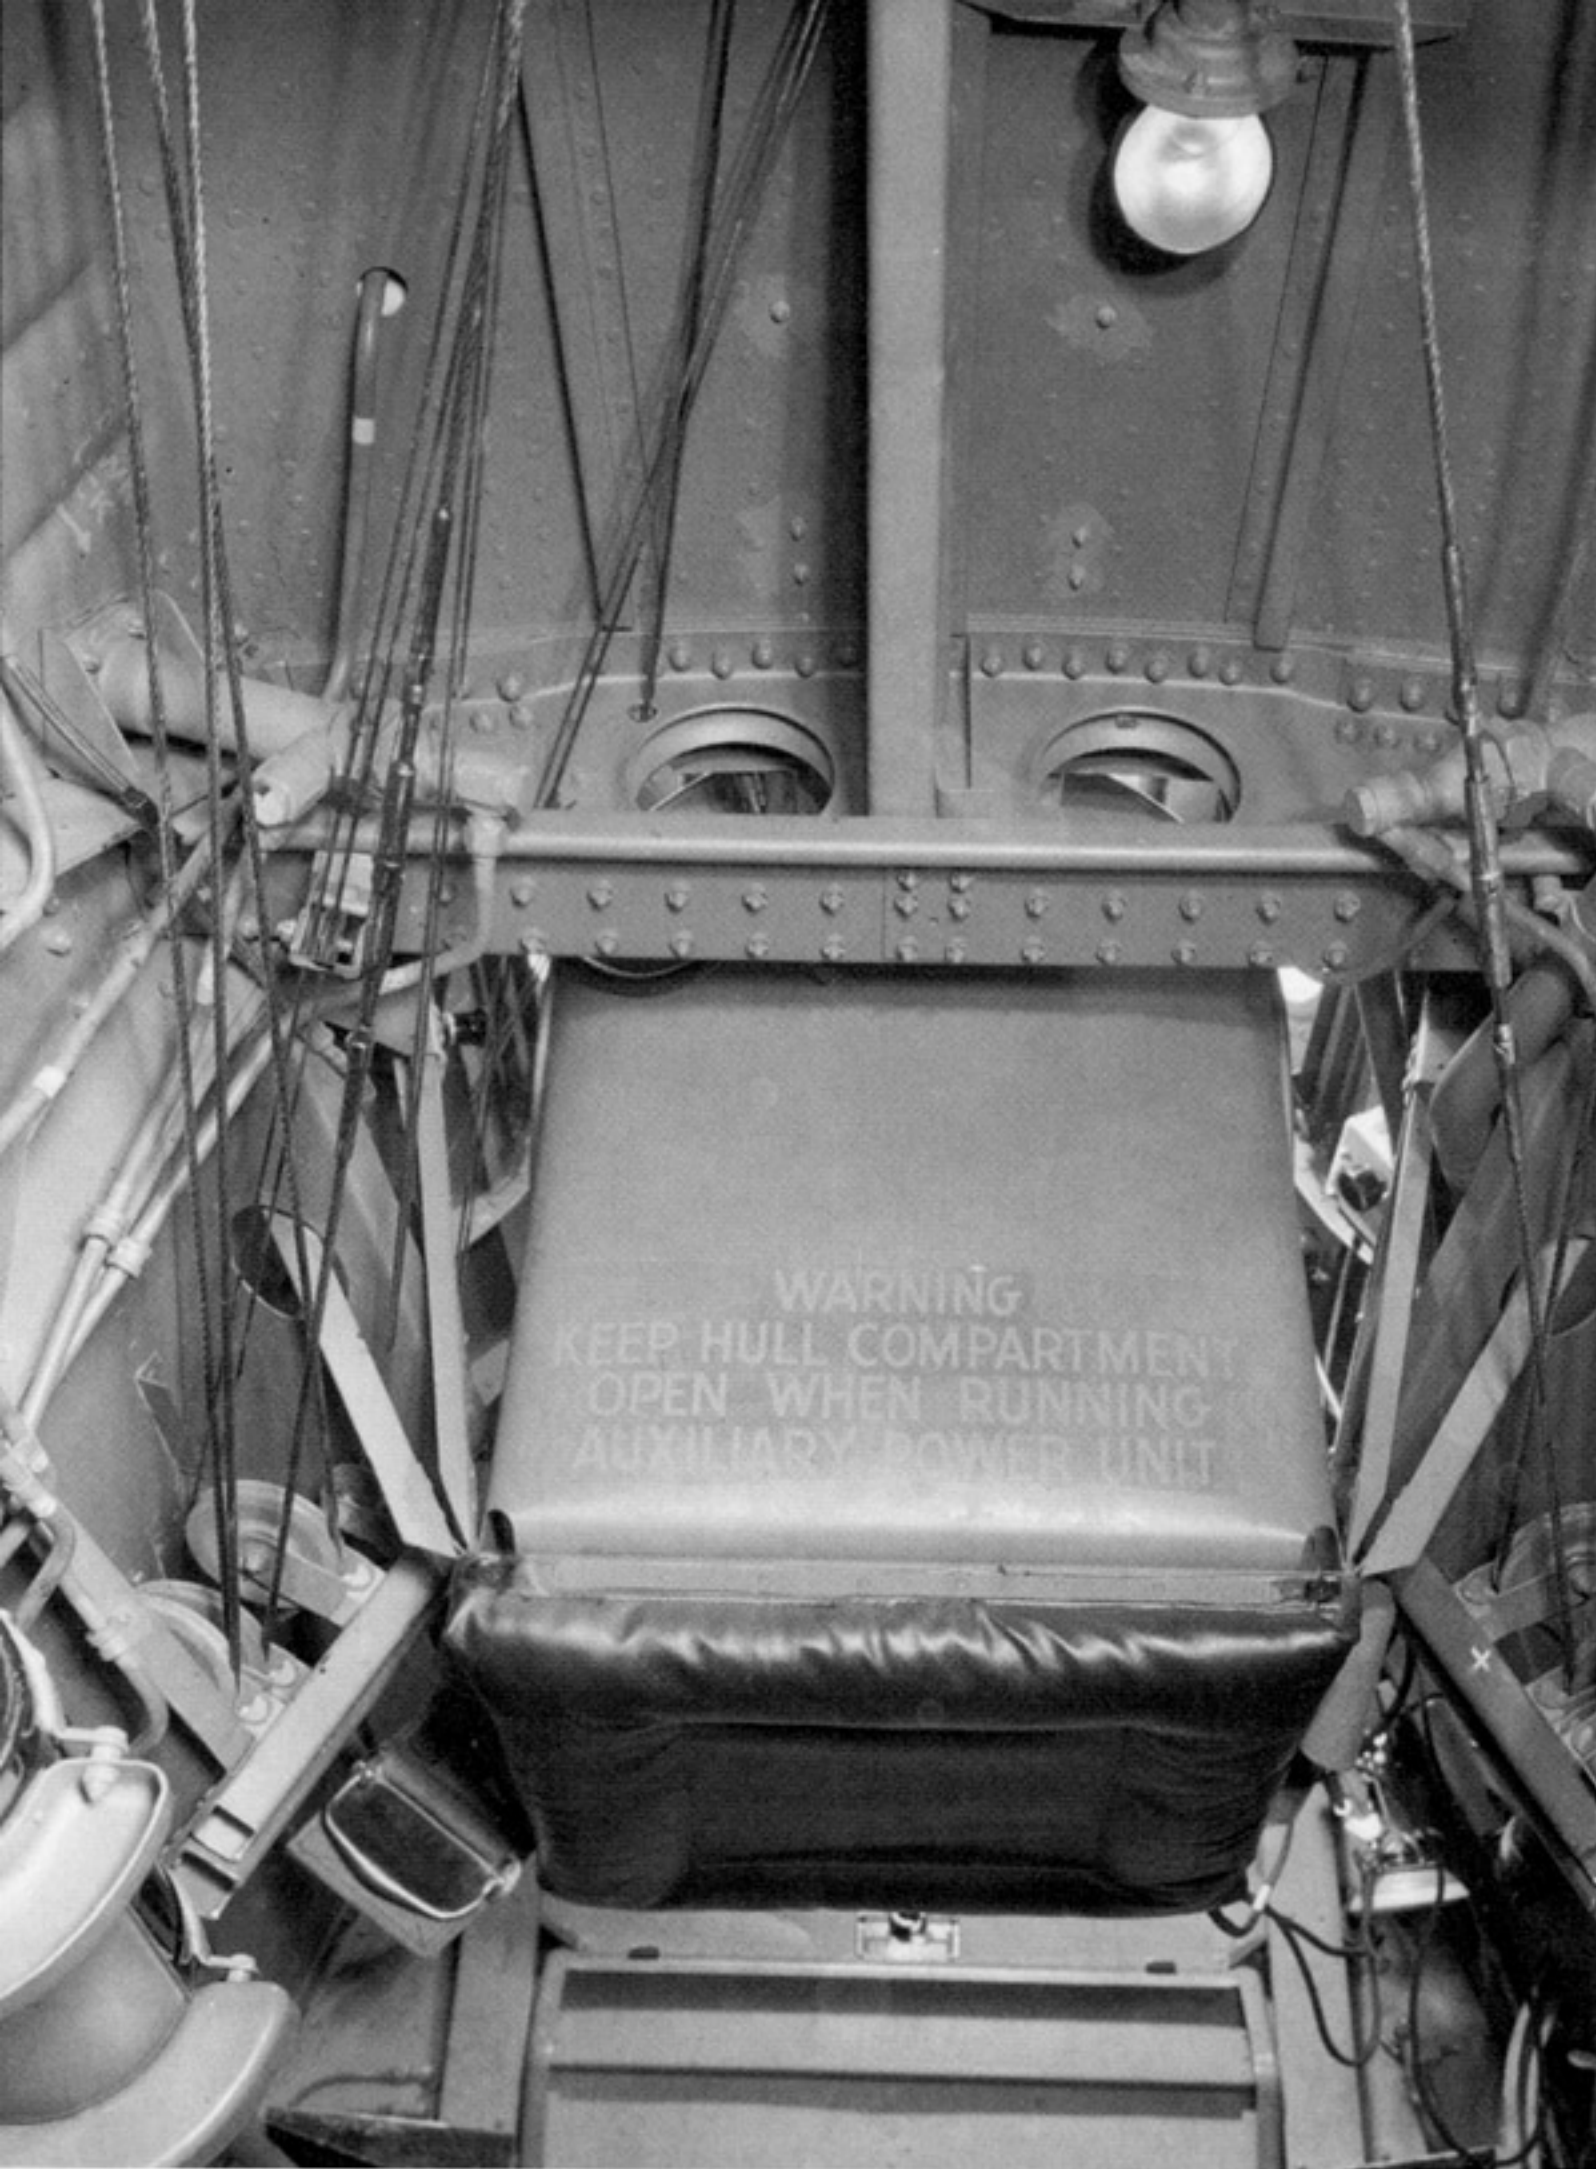
The Mechanic's compartment looking forward and up. At the lower left was the APU fuel tank. Control cables to the tailare on each side of the Mechanic's seat. The cushion was for the protection of crew members walking under the seat. (USN)
